GW SPRINKLER A/S

GW C-300 Deluge Valve Refurbishment / Overhaul

GW C-300 deluge valve – REFURBISHMENT, sequence of operations

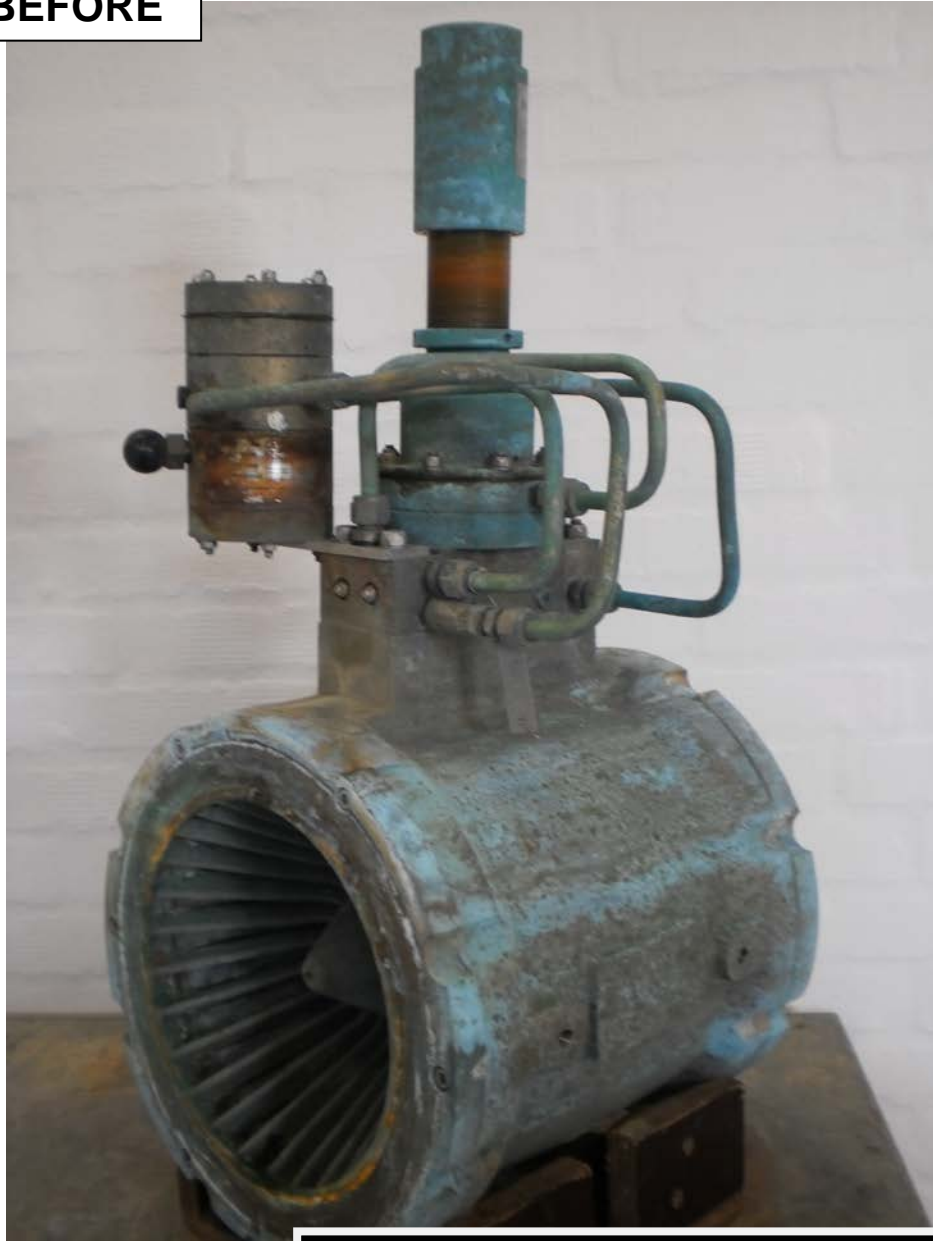
BEFORE

- Valve is received and registered (serial no. and order no.)
 - Refurbishment job is planned in ERP-system.
 - Refurbishment is conducted:
 1. “Before state” photo is taken and stored under valve serial no.

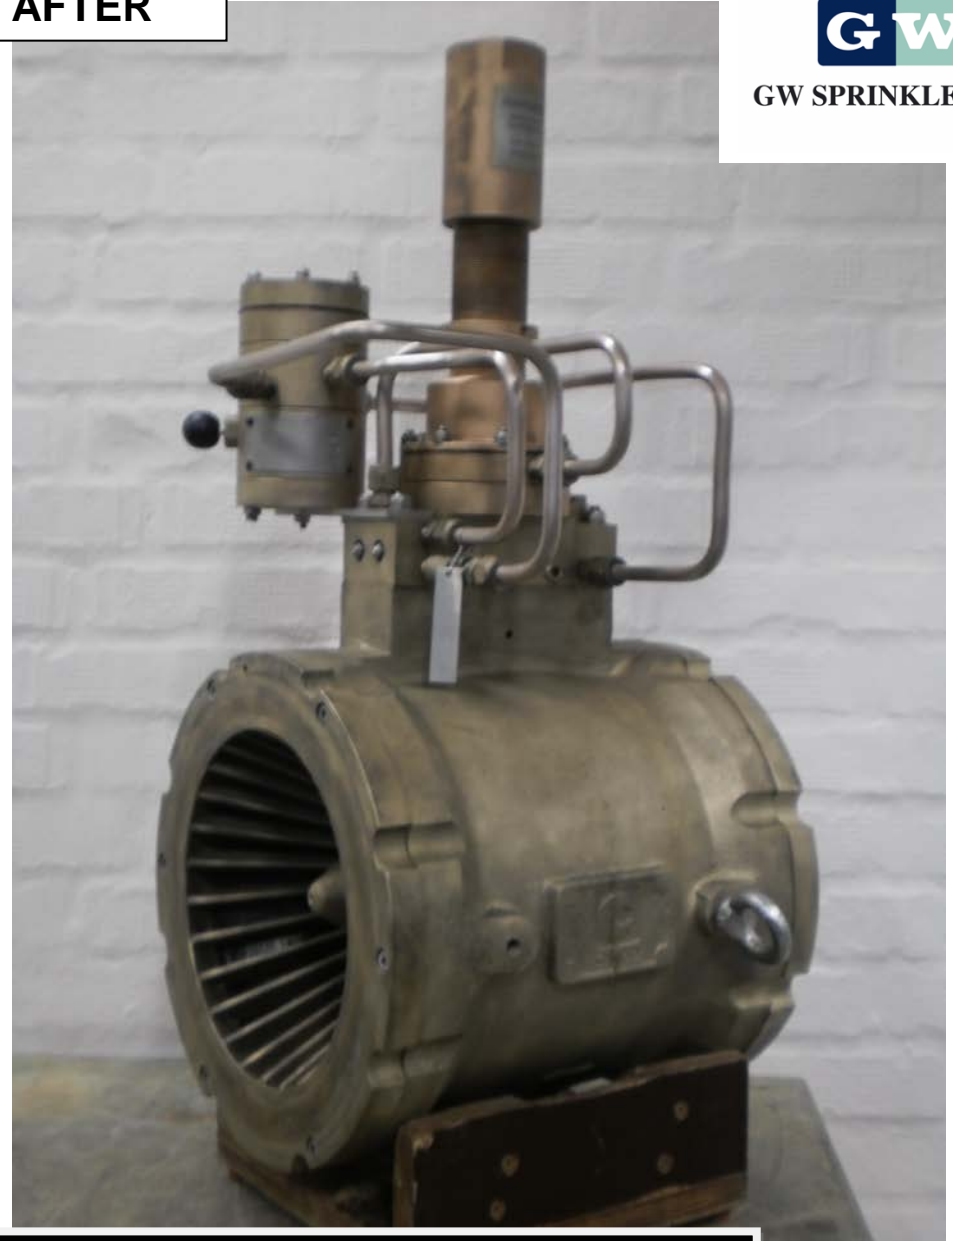
AFTER

9. Moving parts are firmly lubricated.
 10. Valve is re-assembled.
 11. “After state” photo is taken.
 12. Valve is pressure tested (seat: 20 bar / body: 40 bar)
